Inspection Report

Property Address:
XXXXXXXXXX
XXXXXXXXXX MN XXXXX

Strickland Home Inspections

Date: 7/25/2015	Time:	Report ID:
Property: XXXXXXXXXX XXXXXXXXXX MN XXXXX	Customer: XXXXXXXXXXXX XXXXXXXXXXXX	Real Estate Professional:

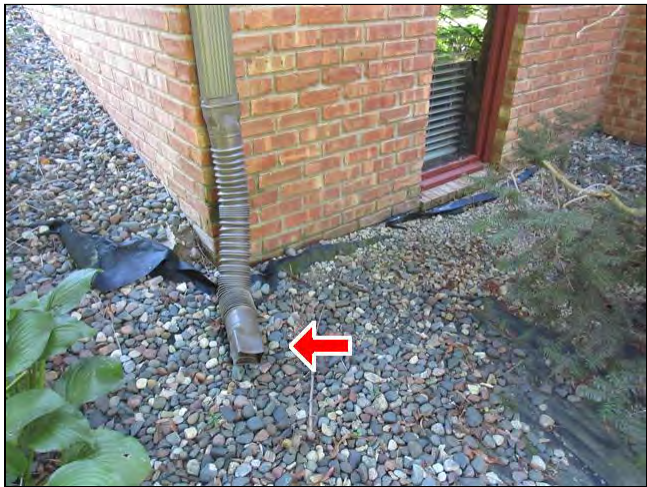
1.2 Down spout extensions should run 6 feet from the building perimeter to ensure all water drains away from the foundation. Add the proper length extension.

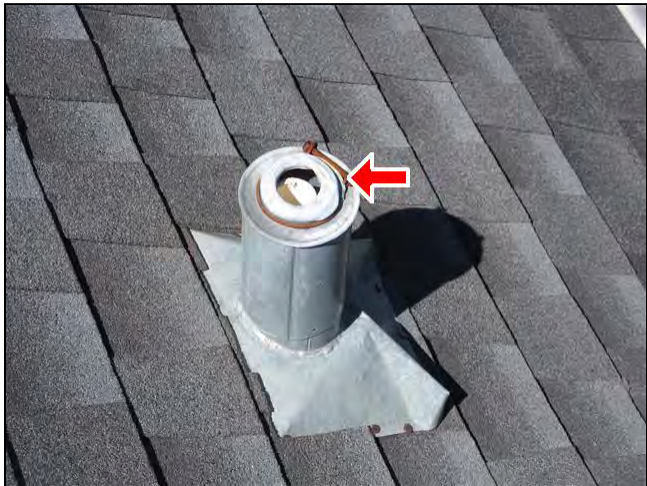
1.4 Lead cap at galvanized plumbing boot needs adjustment to prevent water from leaking along vent pipe top house interior.

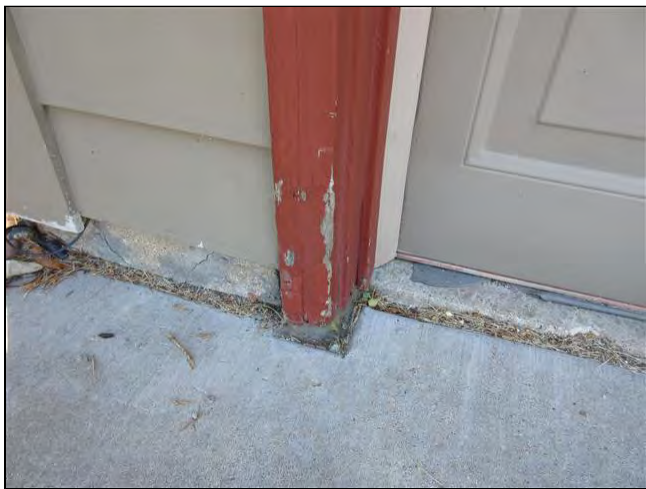
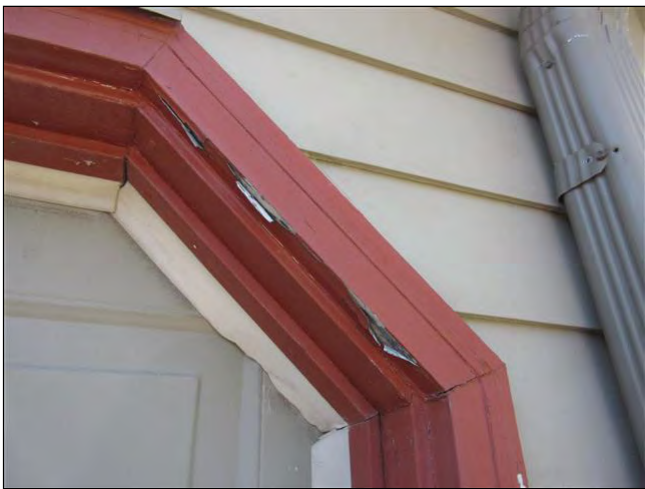
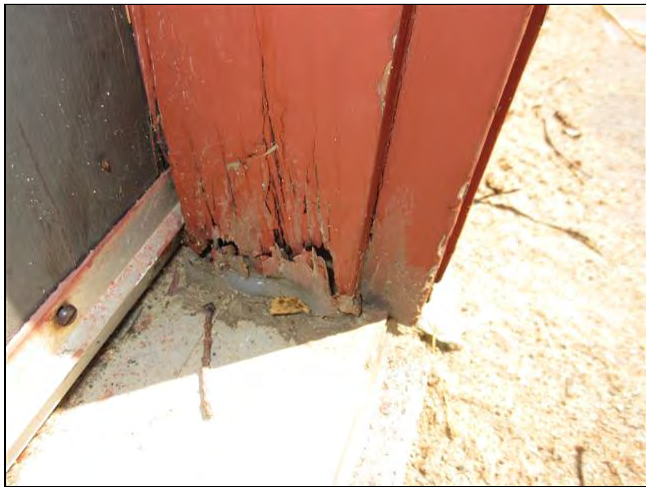
2.0 (1) Peeling paint at trim. Recommend prep, prime, and paint of problem areas.

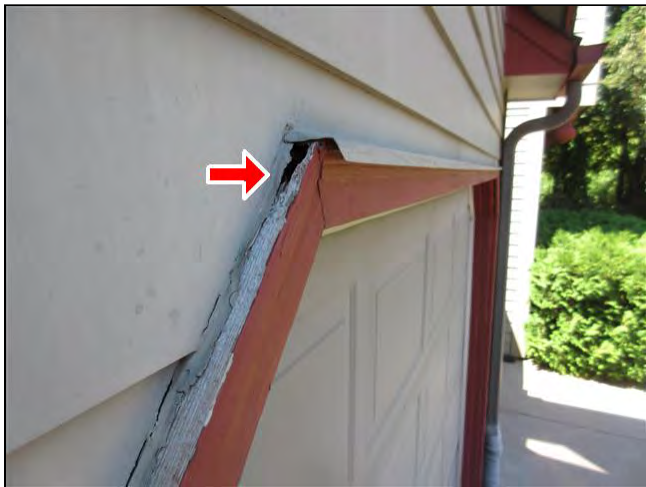
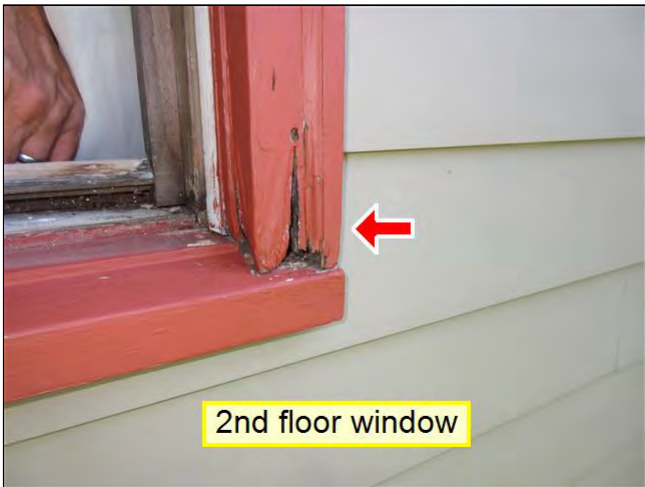
2.0 (2) Some decayed trim noted. Repair any soft wood as needed. Overall condition of the trim is good.

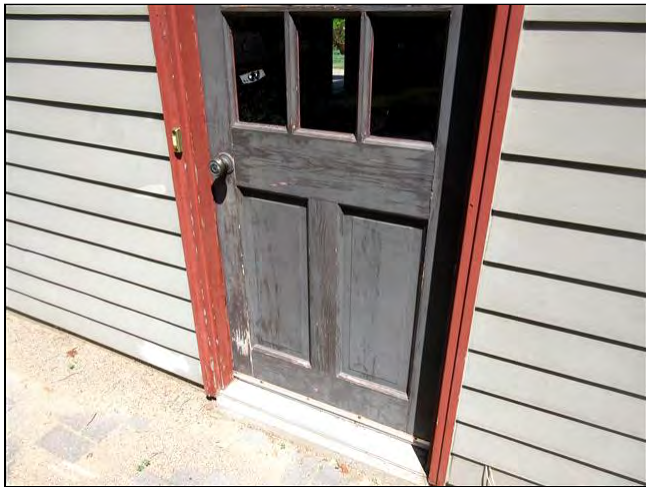
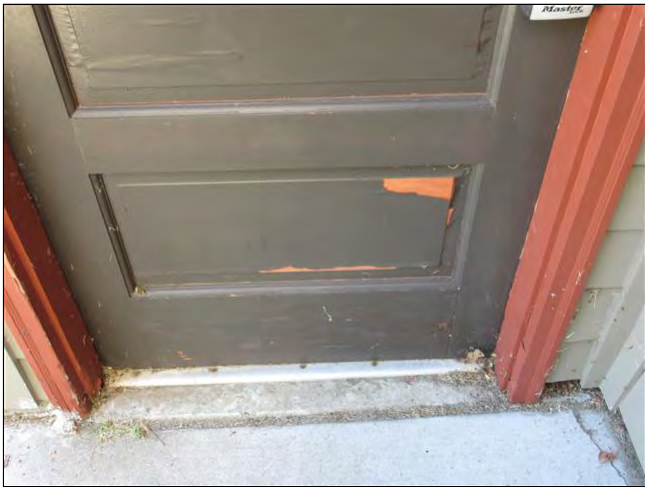
2.3 Peeling paint. Recommend prep, prime, and paint of problem units.

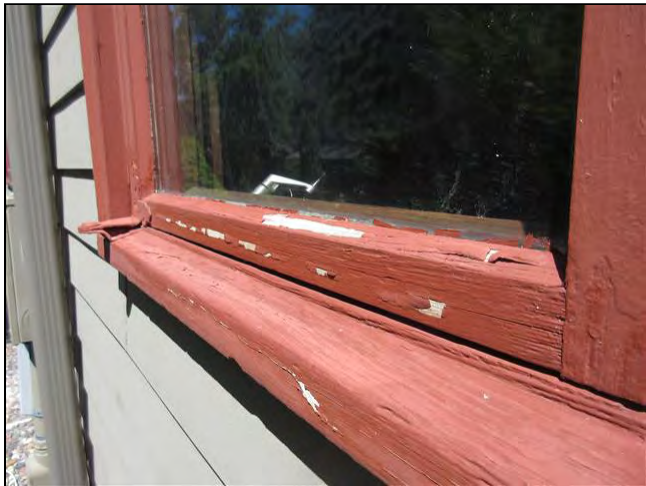
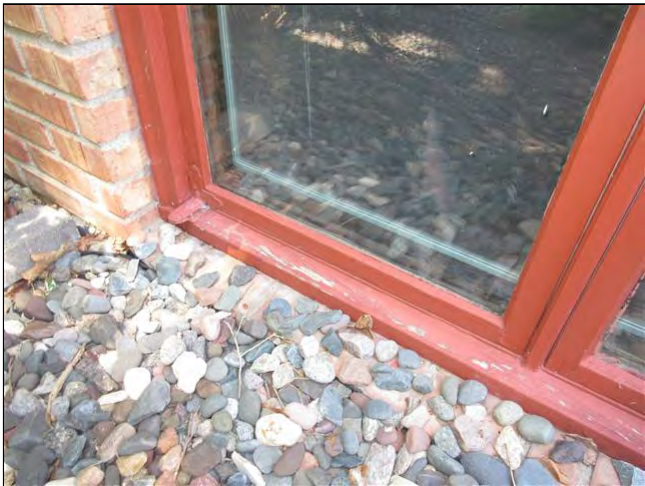
2.4 (1) Peeling paint at multiple units. See comments on windows in Interior section of the report.

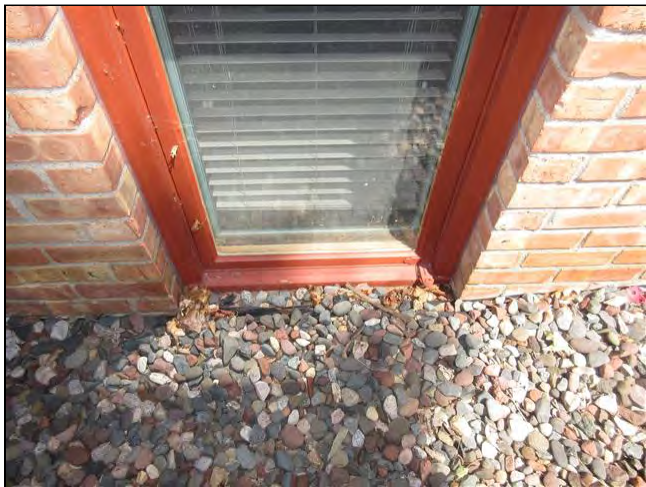
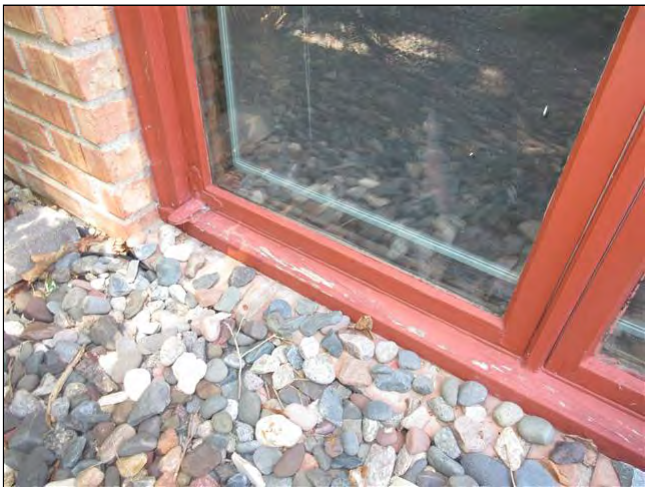
2.4 (2) Noted some basement widows have sills sitting right at grade level. This is problematic over time because the wood soaks up moisture from the ground it is in contact with. Keep good paint coverage to preserve the life of the wood. Also see comments in Grading section.

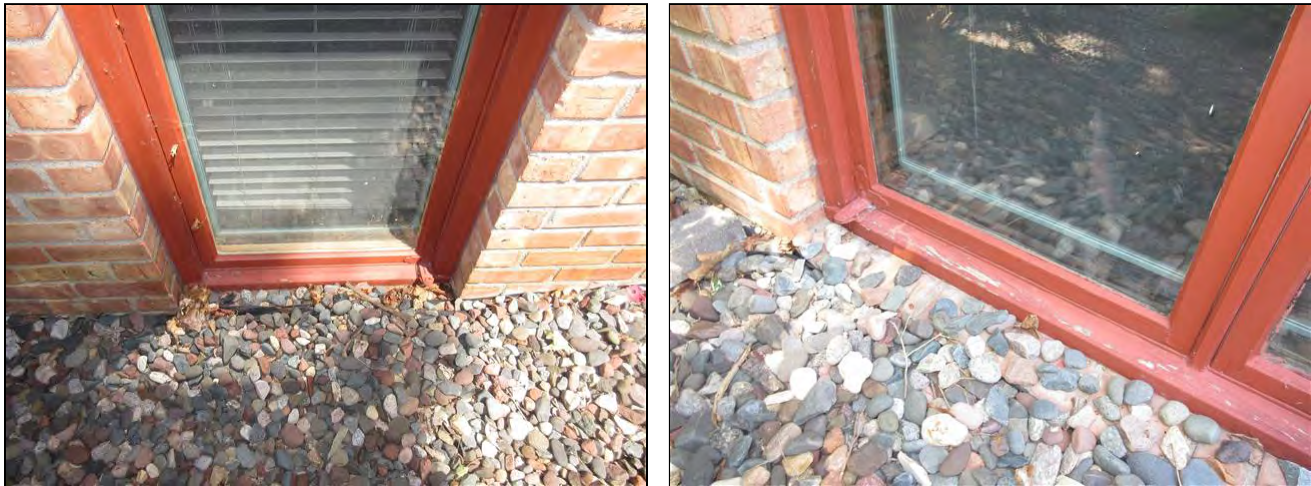
2.7 Some windows sit right at grade level which will lead to decay of the wood components. Make improvements to grading at these areas to prevent contact with the windows.

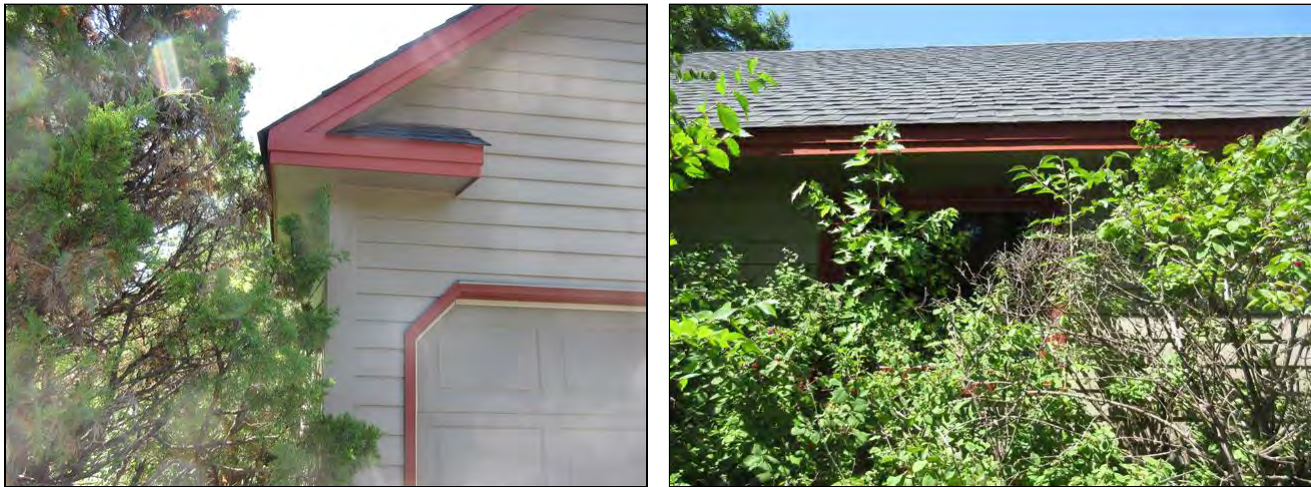
2.8 Tree branches need to be cut back to prevent damage to roofing materials and trim.

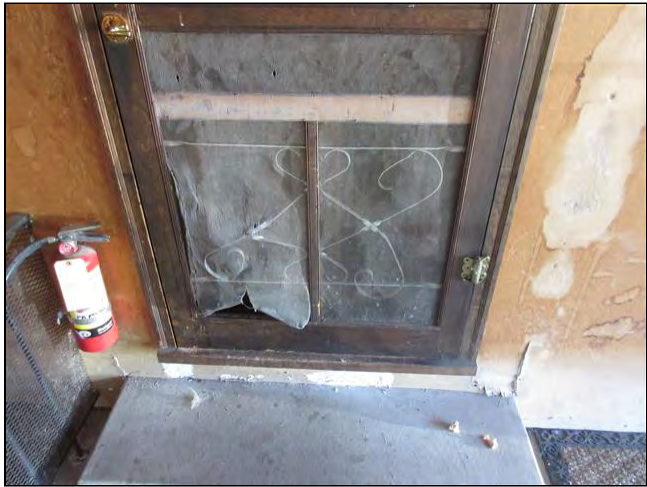
3.5 Damaged screen needs replacement.

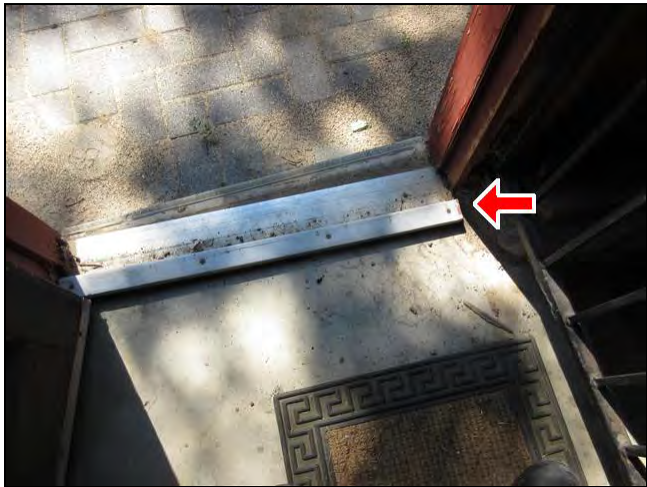
3.6 (1) Loose threshold needs to be secured.

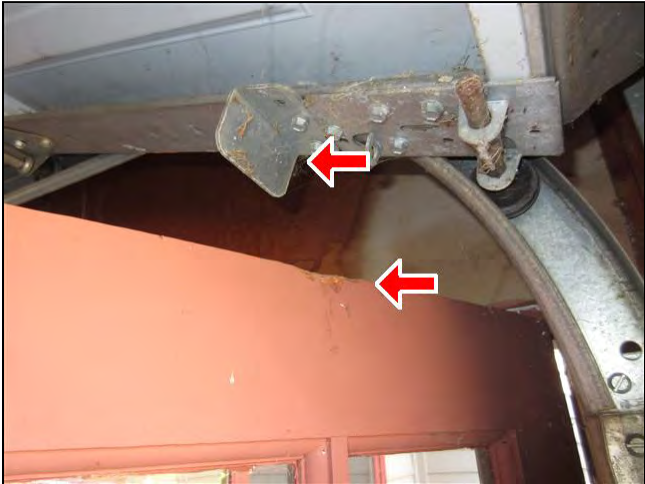
3.6 (2) Noted that if the front service door is opened all the way it can interfere with operation of the overhead door. and may damage either the service door or the overhead door. Ensure service door is closed when operating the overhead door.

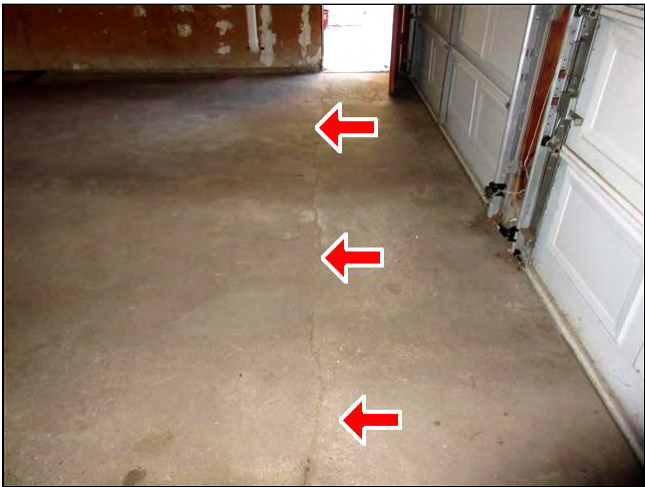
3.8 Cracked slab. Condition is consistent with the age of the structure. No action recommended.

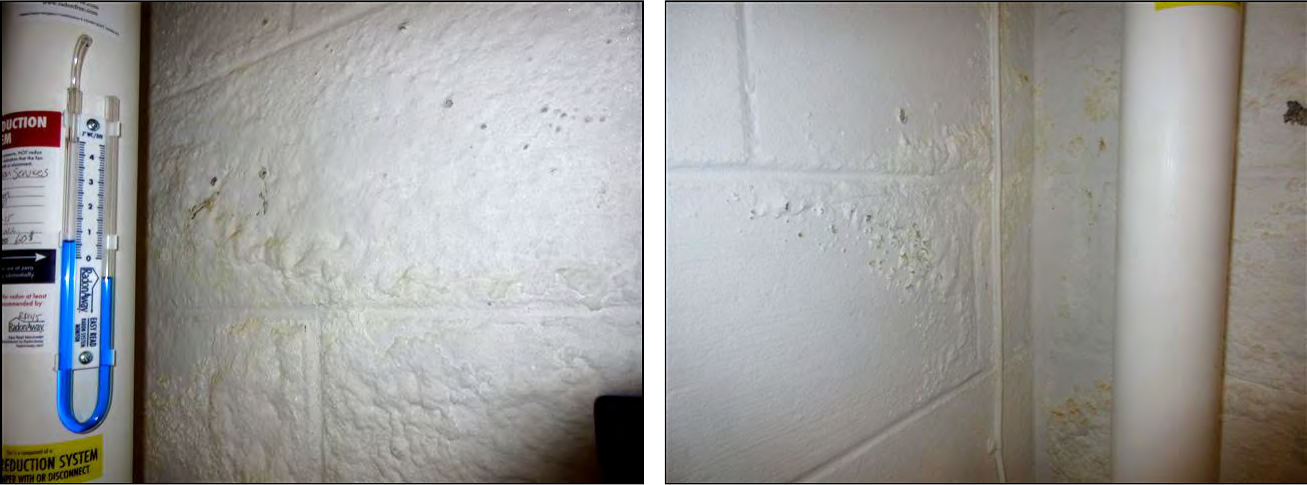
4.1 Noted some slight staining and efflorescence at the wall behind the radon mitigation pipe.

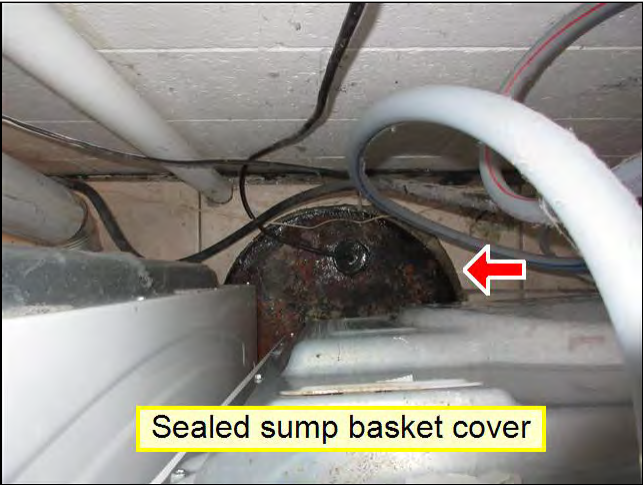
4.2 Basket is sealed as part of the radon mitigation measures, Unable to test pump. Because the basket is sealed, this pump should have a float bypass cord so that the pump can be tested periodically without having to open the basket. Recommend installing a bypass.

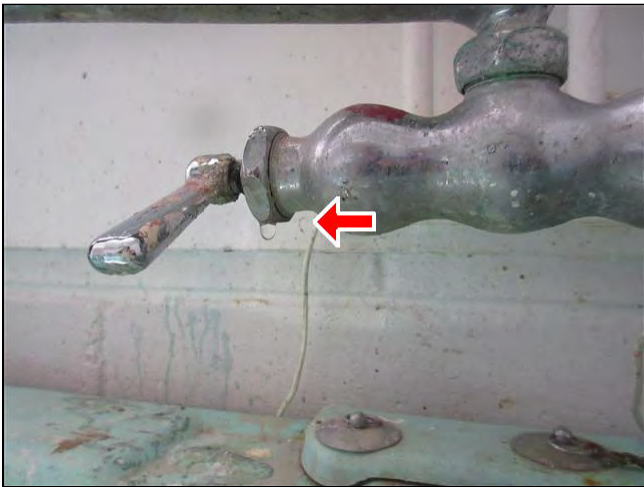
5.0 (1) Leak at laundry tub faucet handle. Repair to faucet needed.

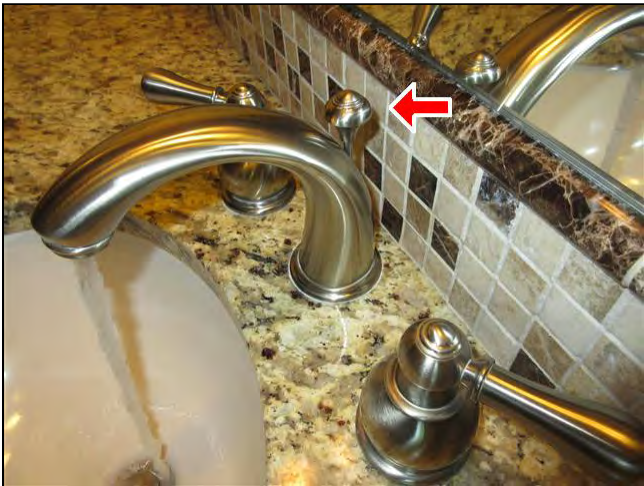
5.0 (2) Non-functioning stopper at upper bathroom sink. Servicing required.

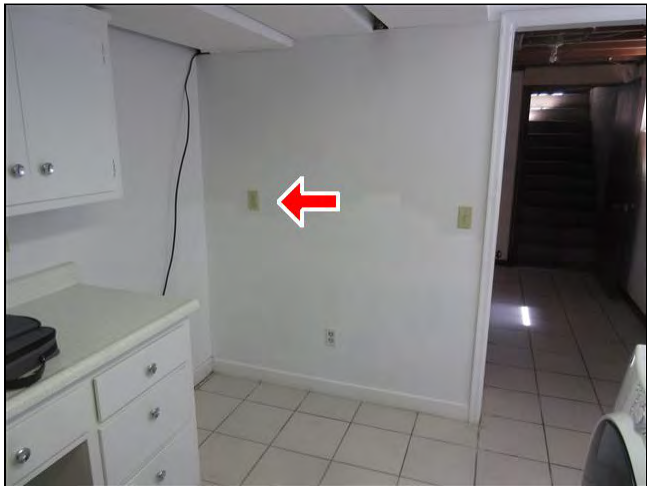
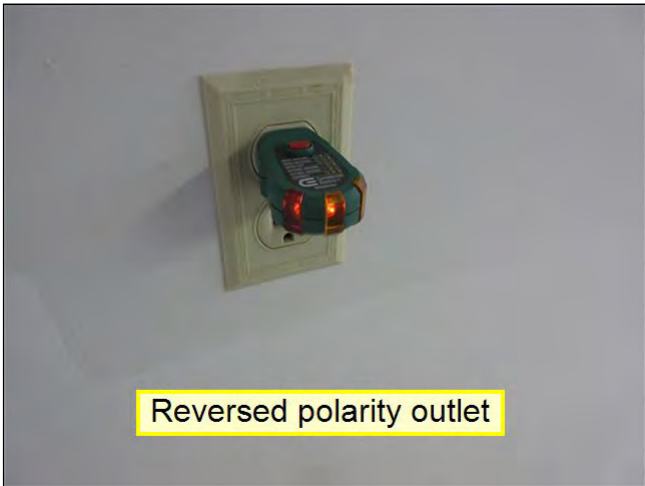
6.4 (1) Reversed polarity outlet at laundry room. Recommend correction by a licensed electrician.

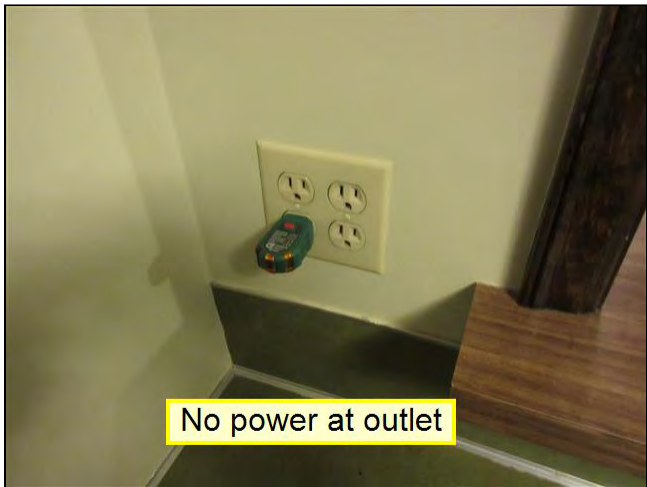
6.4 (2) Noted no power to outlet at basement bathroom. Right hand outlet has power. No power at left outlet. Recommend correction by a licensed electrician.

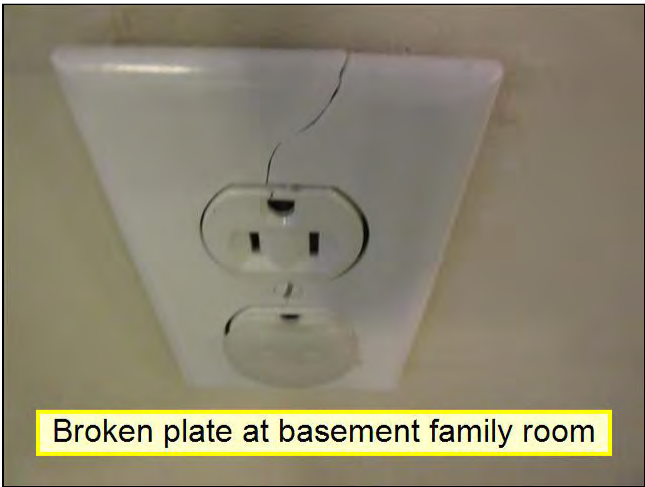
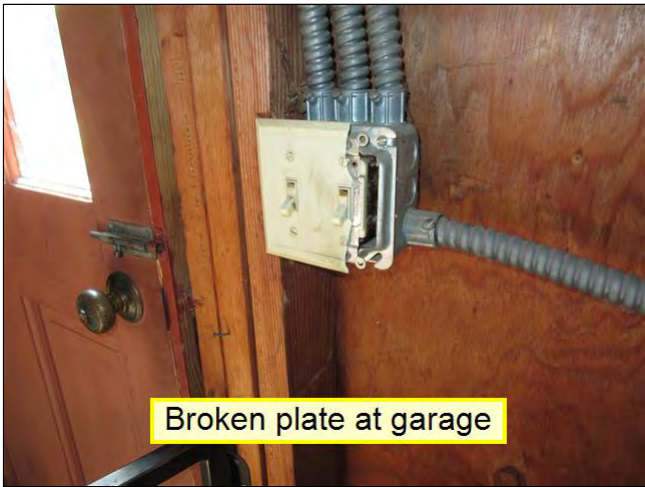
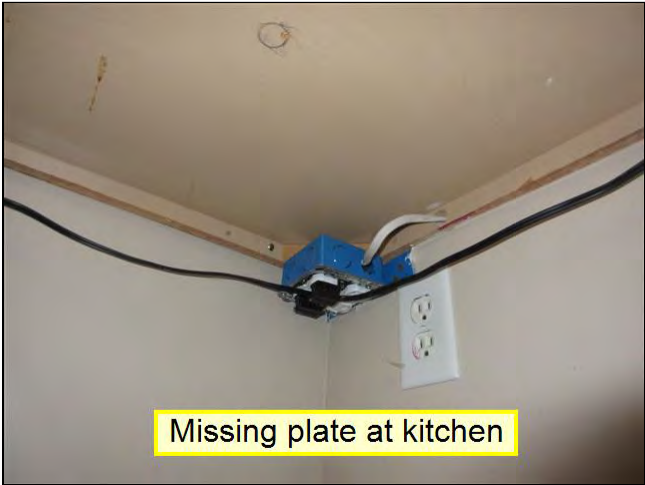
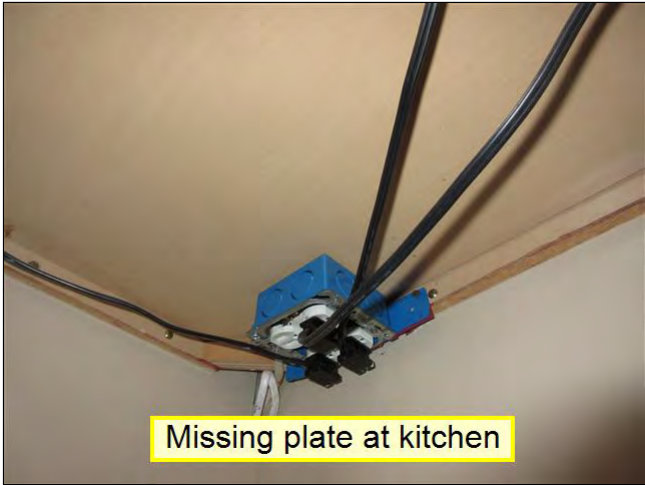
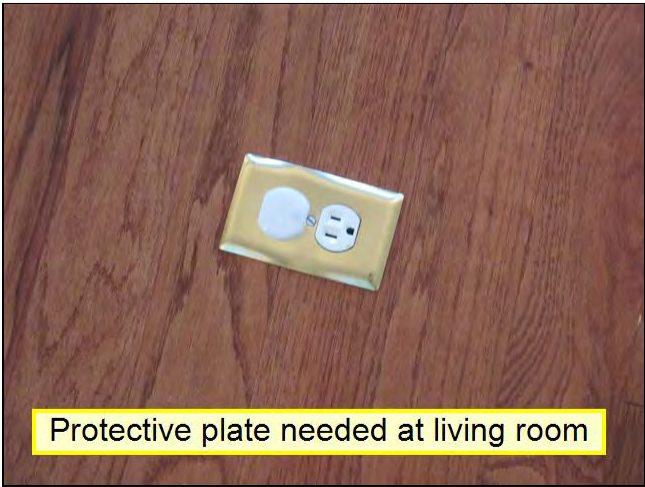
6.4 (3) Replace damaged cover plates and install missing cover plates where needed.

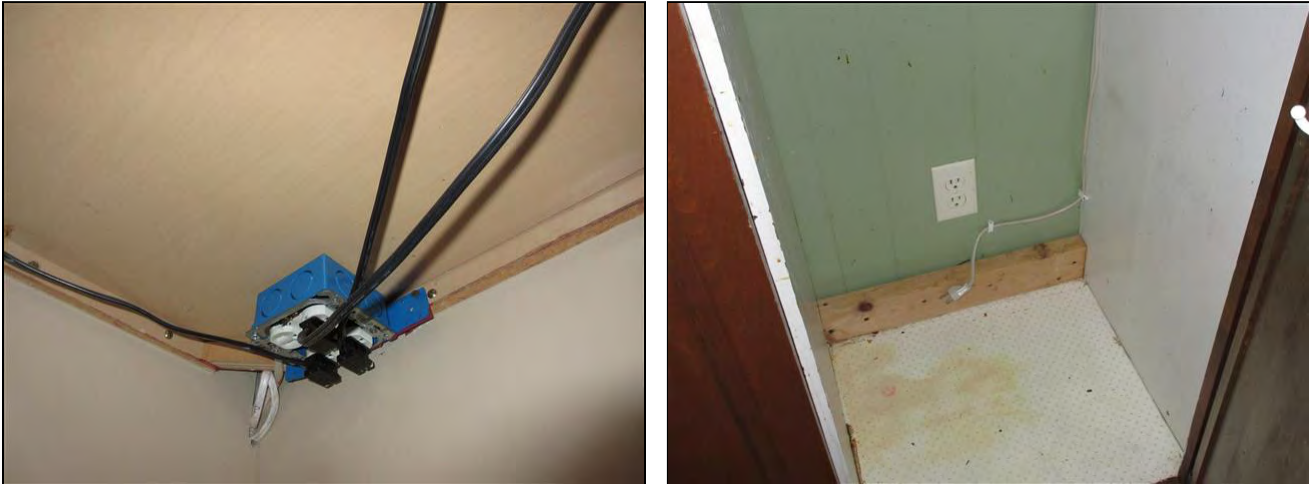
6.4 (4) Wiring at kitchen cabinet lights has been poorly installed. The wires are not supported. Also noted wiring in pantry cabinet is extension cord wiring. All wires should be properly supported as a safety measure.

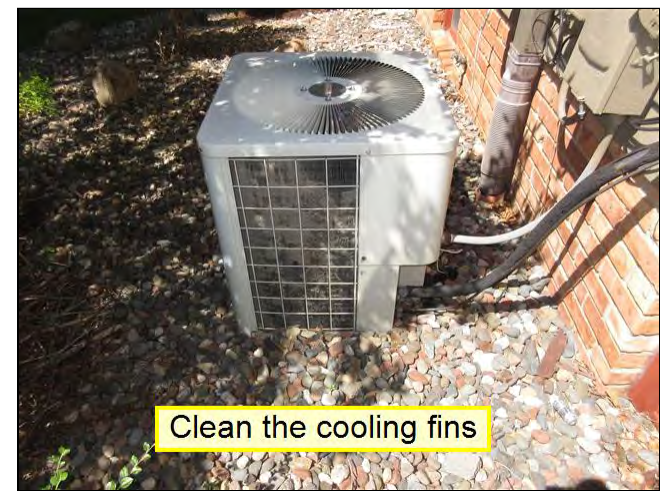
8.1 (1) Cooling fins need to be cleaned.

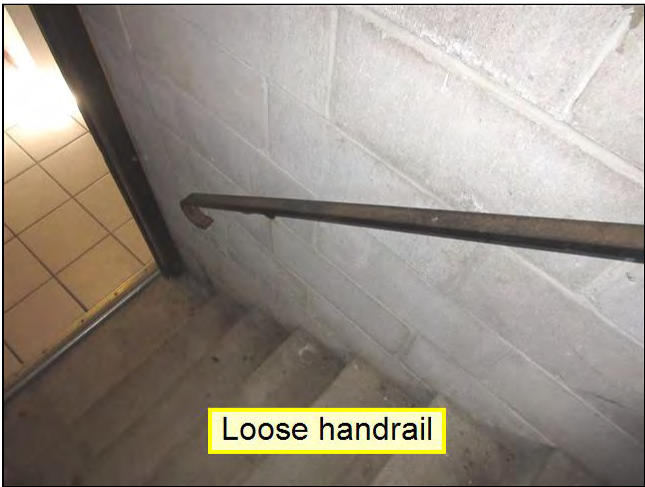
10.3 (1) Tighten loose handrail at garage stairs.

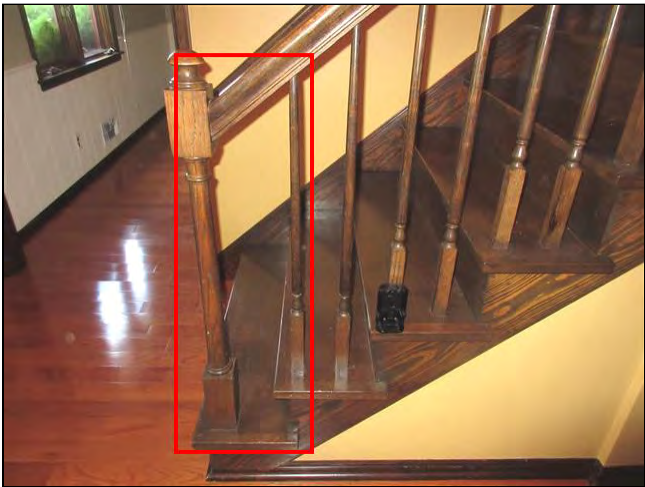
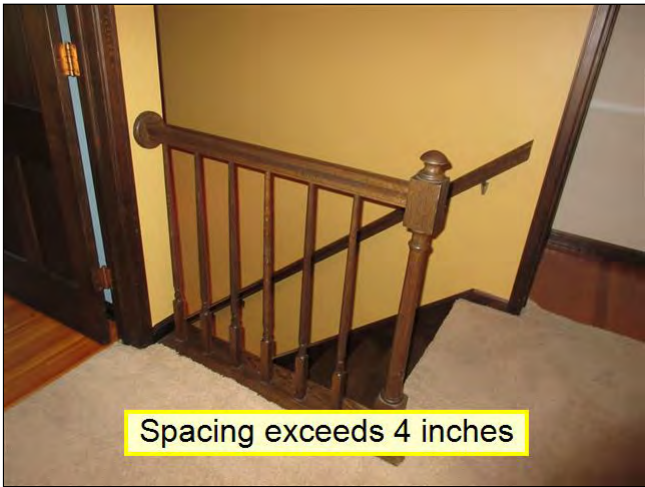
10.3 (2) Noted that spaces between spindles at the guardrails exceed 4 inches which is the present code. For you information only. No action required.

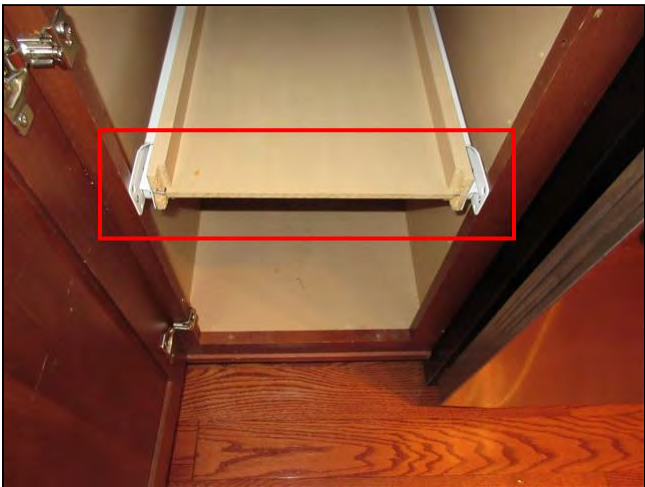
10.4 (1) Missing front rail at kitchen cabinet drawer. Drawer needs repair.

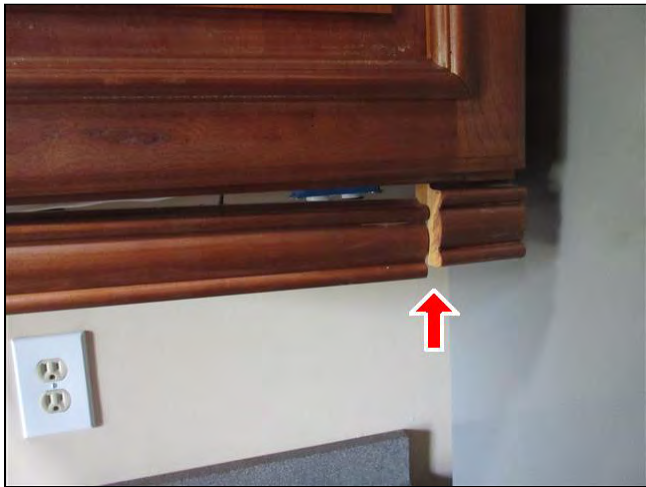
10.4 (2) Loose trim at kitchen wall cabinet needs repair.

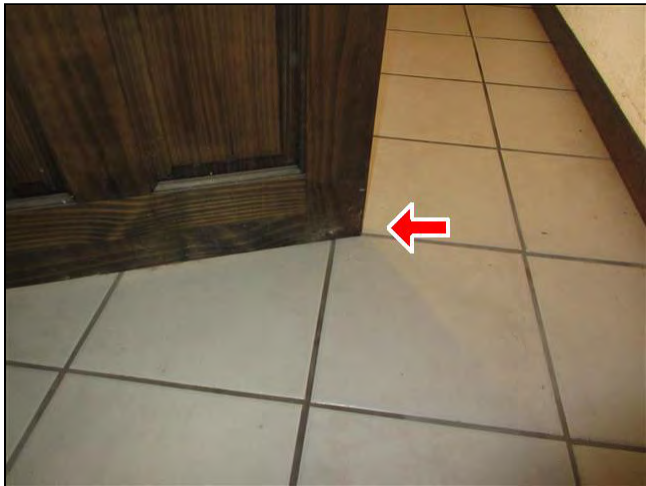
10.5 Door t basement utility area hangs up on floor. Sanding the bottom door edge will improve operation.

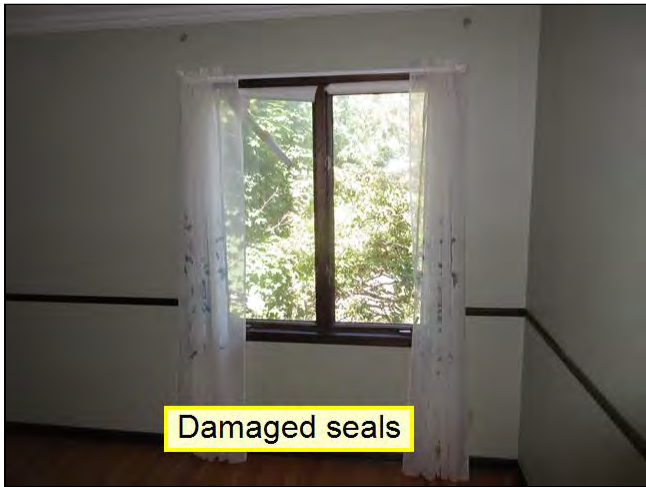
10.6 (1) Damaged seals at two windows at 2nd floor east. These windows should be replaced.

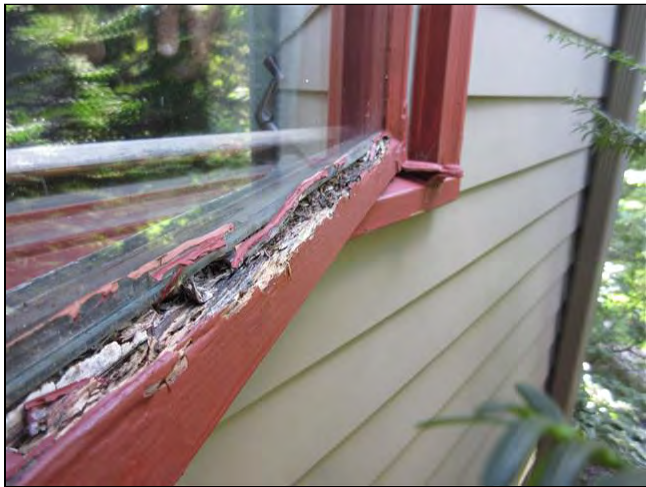
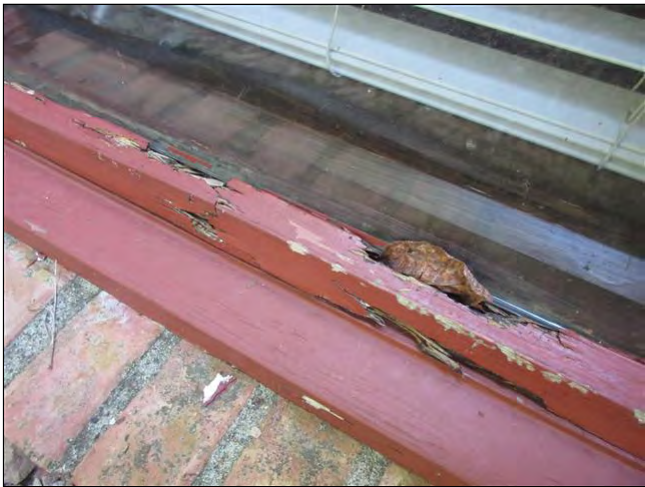
10.6 (2) Extreme decay at one living room and one basement window. Recommend window replacement.

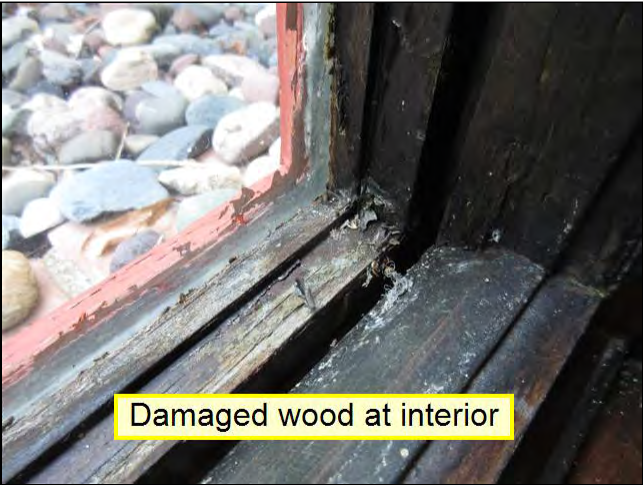
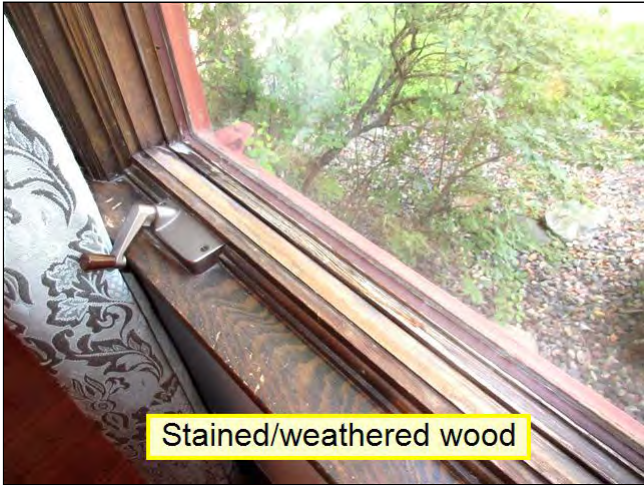
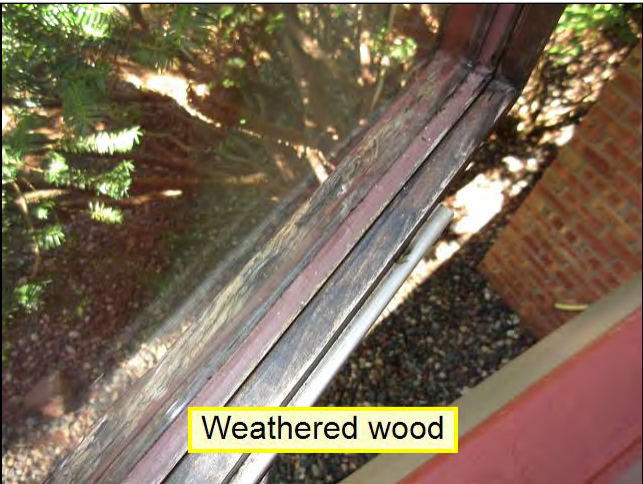
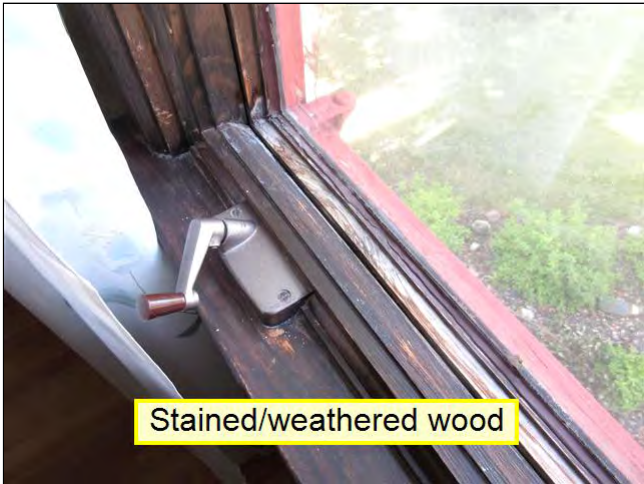
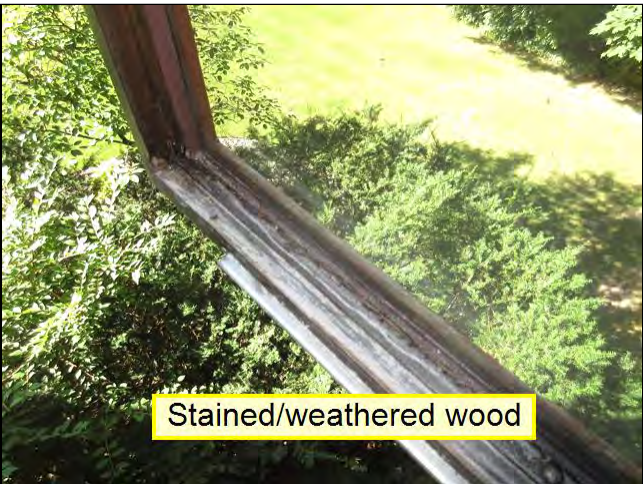
10.6 (3) All original windows in the house are in poor condition. These windows need major service work or replacement. Given the age and condition of the windows and the fact that about 1/3 of the windows have already been replaced, window replacement is the better option at this point.

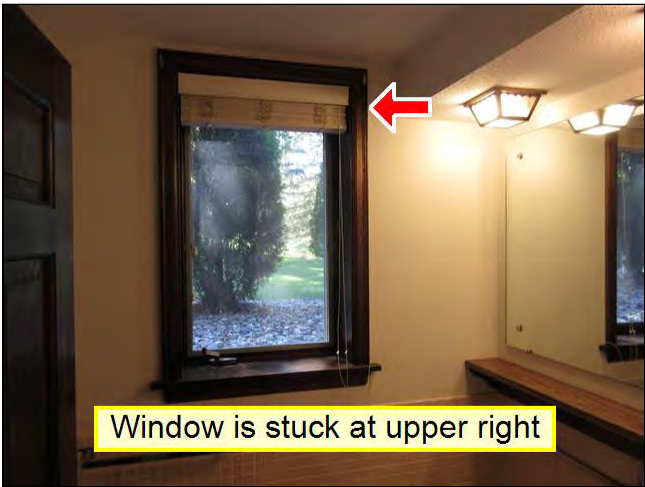
10.6 (4) Window at basement bathroom is stuck at the top and not operational. Servicing required.

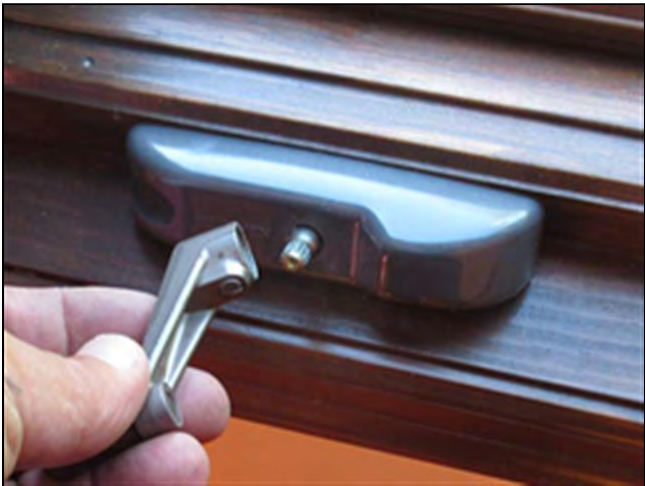
10.6 (5) Loose cranks at 2nd floor northwest bedroom need to be tightened.

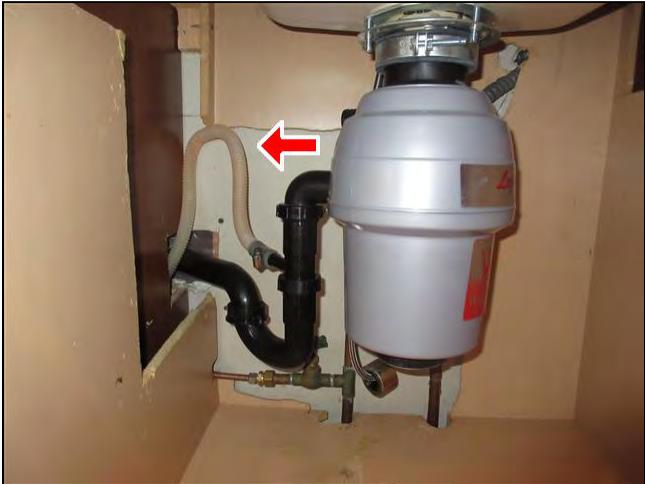
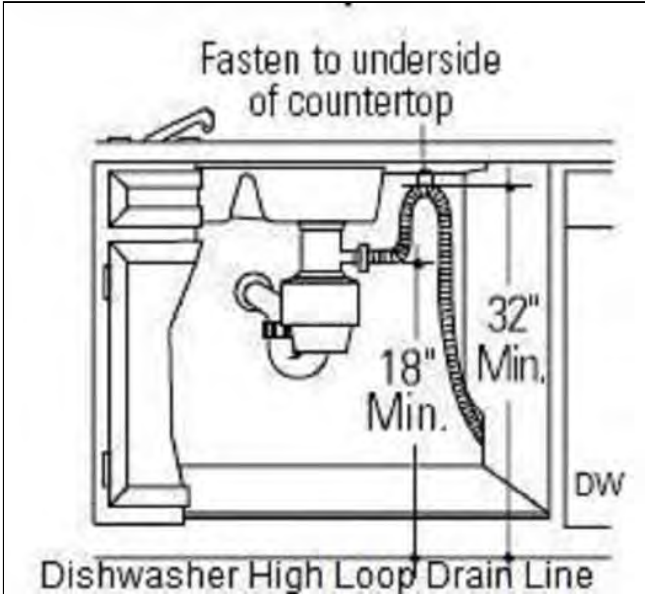
11.2 Dishwasher discharge hose has no high rise loop. The hose should be looped with the top of the loop fastened in the cabinet at a point that is higher than the bottom of the sink basin. The present loop is not high enough.
